URGENT Field Safety Notice

ABL90 FLEX and ABL90 FLEX PLUS

– Risk of incorrect time and potentially biased results

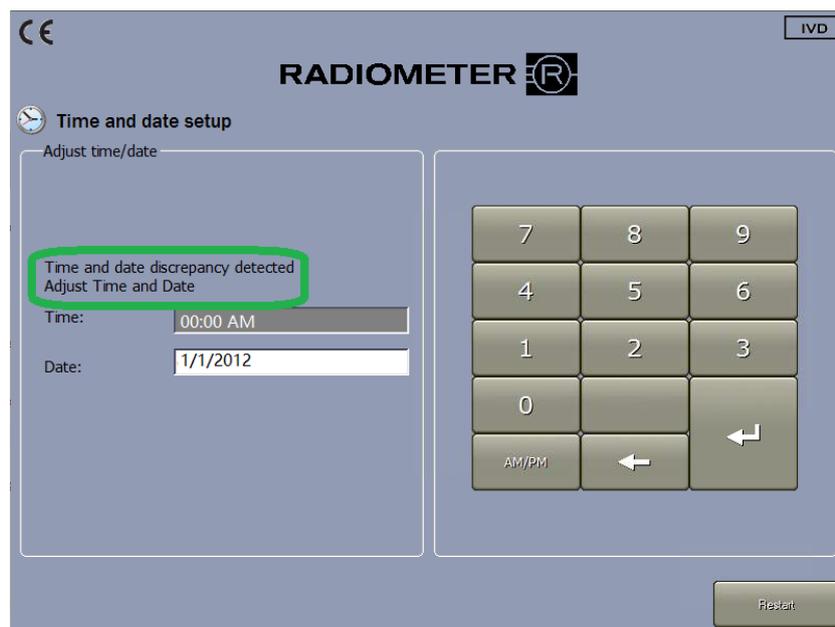
The software update ensures that the analyzer will detect any date and time discrepancy that may appear during a startup following an abrupt power break.

*Time and date discrepancy detected
Adjust Time and Date*

- The operator must then adjust time and date and touch Restart to confirm and restart the analyzer.

If the analyzer shows the above screen during startup then adjust the time and date.
