URGENT FIELD SAFETY NOTICE / PRODUCT NOTIFICATION

Product Reference: ExacTrac Dynamic 1.0.0, 1.0.1, 1.0.2

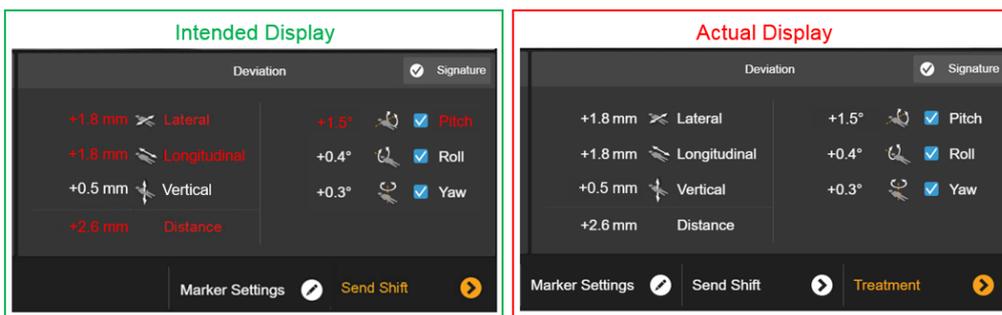
Figure 1: X-ray Verification / X-ray Repositioning page with shift values partly exceeding the predefined X-ray shift tolerances (in this example translation 1 mm, distance 1.7 mm, rotation 1°): Unlike in the intended display (left), the actual display (right) does not show the exceeding shift values in red, and the Treatment button may be displayed.
